DEPARTMENT OF TRANSPORTATION

Quality Assurance and Source Inspection

Contract #: 04-0120F4Cty: SF/ALA Rte: 80 PM: 13.2/13.9File #: 78Fred Hudson.28**WELDING INSPECTION REPORT****Resident Engineer:** Casey, William**Address:** 333 Burma Road**City:** Oakland, CA 94607**Report No:** WIR-030077**Date Inspected:** 28-Sep-2013**Project Name:** SAS Superstructure**OSM Arrival Time:** 700**Prime Contractor:** American Bridge/Fluor Enterprises, a JV**OSM Departure Time:** 1530**Contractor:** Steward Machine Co.**Location:** Birmingham, AL**CWI Name:** Fred Hudson**CWI Present:** Yes No**Inspected CWI report:** Yes No N/A**Rod Oven in Use:** Yes No N/A**Electrode to specification:** Yes No N/A**Weld Procedures Followed:** Yes No N/A**Qualified Welders:** Yes No N/A**Verified Joint Fit-up:** Yes No N/A**Approved Drawings:** Yes No N/A**Approved WPS:** Yes No N/A**Delayed / Cancelled:** Yes No N/A**Bridge No:** 34-0006**Component:** E2 Shear Key Anchorages**Summary of Items Observed:**

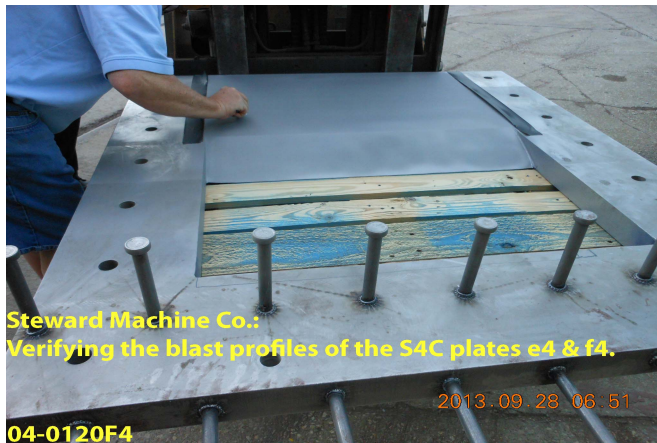
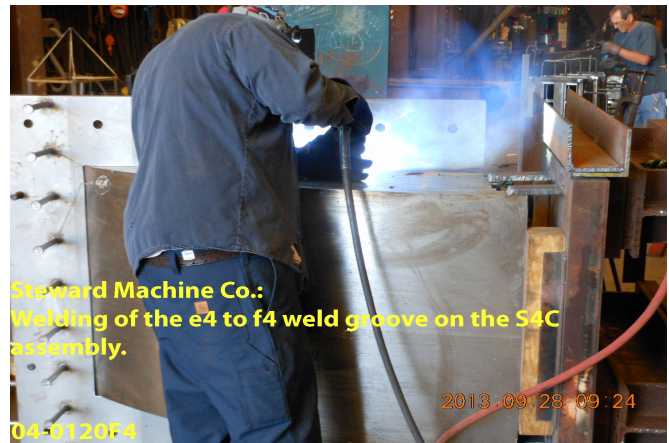
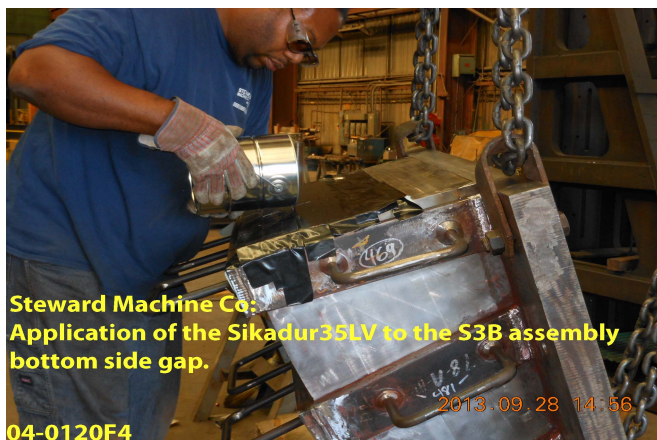
The assembly was removed from CNC #231. Strap welds for J3, K4, M4, P4 & R3 were observed cleaned for Magnetic Particle Testing. After cleaning and MT of strap welds the Sikadur 35 LV was applied to fill gaps between plates as required by contract drawings.

Steward shop personnel were observed blasting and verifying blast profiles for the e4 & f4 plates faying surfaces before assembly and welding the root pass. After root pass MT of both sides the welder began running cover passes to fill the weld groove. Welding was performed by welder Jeff Hennington (#476) utilizing Welding Procedure Specifications (WPS) P2-W128-B and P2-W126-B for FCAW-G in the 1G position. The welding parameters were observed adjusted and monitored by Certified Welding Inspector (CWI) Fred Hudson (Cert.

S4C: Root pass for the e4 to f4 plates weld grooves on sides A & B. (MT acceptable. See TL-6028 for MT report)

S3B: Strap PJP Welds and S3 Fillet welds on side B. (MT acceptable. See TL-6028 for MT report)
